**LHC Project Report 905**

**Identification of Assembly Faults through the Detection of Magnetic Field Anomalies  
in the Production of the LHC Dipoles**

C. Vollinger, E. Todesco

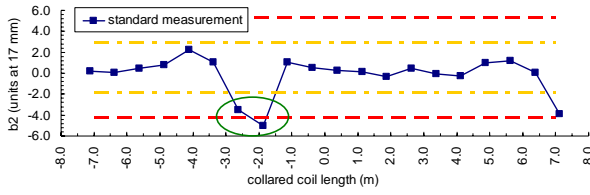
**The missing shim:** Fig. 2 shows the measurement of  $b_2$  with a yellow and red alarm corresponding to field anomalies of 6.6 and 9.2 (see circle on the plot). The inverse calculation indicated that an increase of the coil size azimuthally of about 0.6 to 1 mm on the outer layer gives a residual anomaly within 4. This was suggesting a missing shim in the outer layer pole, whose thickness is 0.8 mm. This prediction was confirmed by the de-collaring (Fig. 3). We have observed one case of a missing pole shim so far.

Fig. 2. Measurement of multipole  $b_2$  along the magnet axis with alarm limits at  $4\sigma$  and  $8\sigma$  (dashed lines) for a collared coil with missing pole shim.

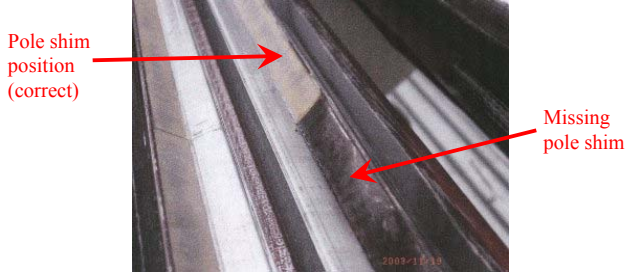
Fig. 3. Missing pole shim observed after de-collaring.

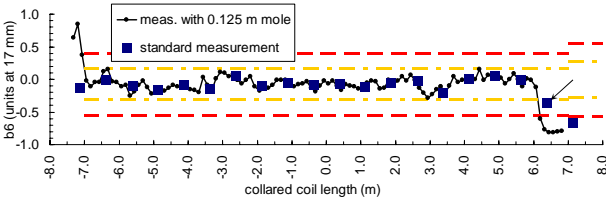
**The sliding shim:** Fig. 4 shows the measurement of multipole  $b_6$  indicating a yellow alarm from the standard measurement (triangle markers) and red alarms from the short mole measurement (see arrow indicator). On this collared coil, alarms on various multipoles were observed in the last measurement position in the straight part before the non-connection side coil end (see the anomaly of the lower order multipoles in tab. I).

MEASURED MULTIPOLES ANOMALY IN THE DEFECT POSITION									
$b_n$	2	4	6	8	$a_n$	2	4	5	7
$\beta$	7.5	4.9	5.5	5.9	$\alpha$	5.5	6.8	5.5	5.2

Fig. 4. Measurement of multipole  $b_6$  along the magnet axis with alarm limits at  $4\sigma$  and  $8\sigma$  (dashed lines) for a collared coil with a misplaced pole shim.

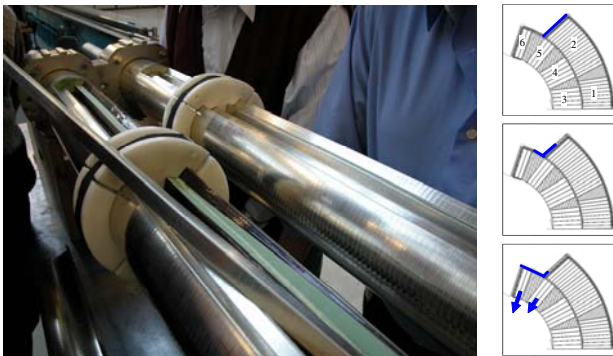
The inverse calculation of the values in table I shows that a movement of block 5 of about 0.3 mm together with a movement of block 6 of about 0.6 to 1 mm, both radially inwards, would give a residual anomaly within 4. Please note that a movement of one block only does not explain the anomaly. After de-collaring, we observed that an outer pole shim of 0.8 mm thickness had slid downward, pushing blocks 5 and 6 towards the centre of the aperture as shown in Fig. 4. On the right side of Fig. 5, it is illustrated in three steps how the pole shim is sliding onto the conductor blocks 5 and 6. We have observed two cases of a sliding pole shim so far.

Fig. 5. Left: Movement of blocks 5 and 6 of the inner layer of the coil observed after de-collaring due to a misplaced pole shim of 0.8 mm thickness. Right: Illustration of the predicted defect and block numbering.

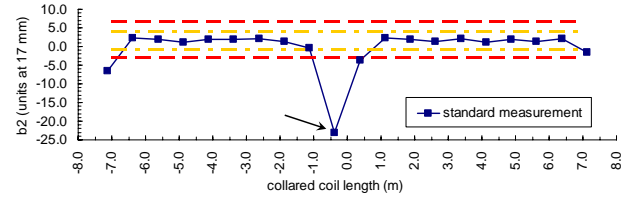
**The double coil protection sheet:** This was the fourth magnet of the production, and the control limits had not yet been set. A very strong anomaly in the main field (40 units) was observed along 0.75 m in the central part of the magnet, associated to a peak in  $b_2$  (see Fig. 6). The inverse calculation methods were not yet set. Due to the amplitude of the anomaly, the magnet has been decollared, finding a double coil protection sheet of 0.5 mm thickness on a length of 1 m in this measurement position (see Fig. 7). Simulations of the effect of this error on field quality done a posteriori are in agreement with the measured anomaly. We have observed one case of a double coil protection sheet so far.

Fig. 6. Measurement of multipole  $b_2$  along the magnet axis with alarm limits at  $4\sigma$  and  $8\sigma$  (dashed lines) in the straight part.

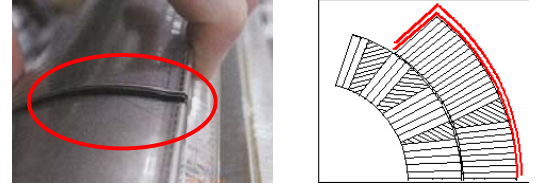
Fig. 7. Assembly of a double coil protection sheet observed after de-collaring (left); illustration of the defect (right).

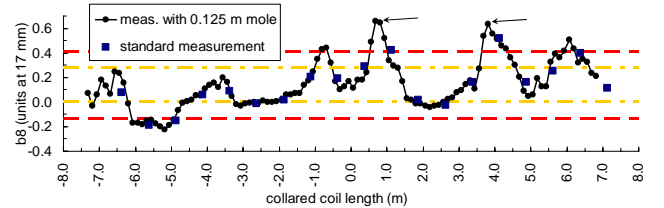
**Bad coil curing:** Conductor displacements in block 6 due to a bad curing of the coil could be identified by individual multipole alarms in isolated positions along the axis. In several cases, the standard measurement was followed by a special measurement using the 0.125 m long coil to have a better resolution along the magnet axis. The longitudinal size of these defects proved to be rather small (0.01 to 0.02 m).

An inward radial displacement of block 6 in one quadrant mainly affects  $a_6$  and  $b_8$ . Fig. 8 shows the measurement of multipole  $b_8$  taken on a collared coil with a standard and a detailed measurement (triangle markers and continuous line). The field anomaly of the short mole measurement is very strong, i.e., up to 12-13. For the two positions indicated with arrows, an inverse calculation of the pattern of all multipoles in this position indicated an inward radial movement of block 6 of 0.5 to 0.8 mm. Fig. 9 shows one of these positions after decollaring: block 6 is found not to be glued to the inner layer, thus leading a inward displacement in the assembly. We have observed 7 cases of bad curing so far. Corrective actions have been taken in the curing cycle to avoid this problem.

Fig. 8. Measurement of multipole  $b_8$  along the magnet axis with alarm limits at  $4\sigma$  and  $8\sigma$  (dashed lines) for a collared coil with curing problem.

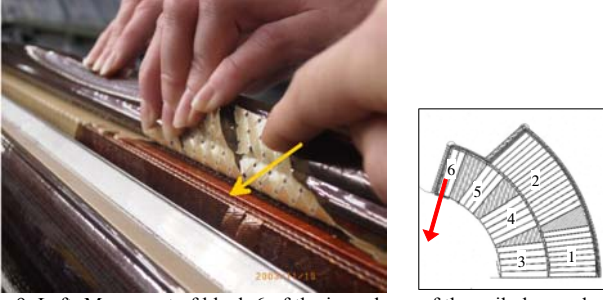
Fig. 9. Left: Movement of block 6 of the inner layer of the coil observed after de-collaring. Right: Illustration of the predicted defect and block numbering.

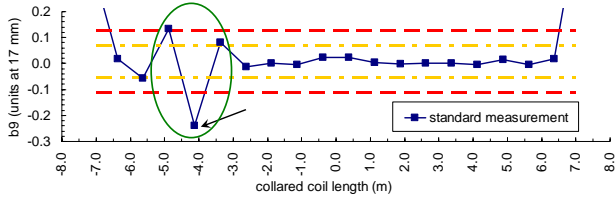
**Magnetic anomalies in the cold bore tube:** One collared coil showed yellow and red alarms on various multipoles, especially on the higher orders (see Table II), of which one of the strongest signals, multipole  $b_9$ , is shown in Fig. 10. From the calculation, no solution was found, but the very strong impact on high orders suggested that the source of the error was very close to the centre of the aperture, even closer than the inner layer. For this reason, the magnet was reassembled with the cold bore rotated (connection side at the place of non connection side). A second measurement showed that the defect had changed longitudinal position. The tube was then removed, and a permeability measurement showed an out of tolerance over the expected section. We have observed two cases with a faulty cold bore tube. Even though this field perturbation is not endangering the beam, in both cases the cold bore tube has been replaced.

$b_n$	4	6	9	11	$a_n$	6	7	8	11
$\beta$	8.2	11.1	16	10.1	$\alpha$	7.1	10.7	15.3	12.2

Fig. 10: Measurement of multipole  $b_9$  along the magnet axis with alarm limits (dashed lines) for a collared coil with a defect in the material features of the circular cold bore tube (CBT).

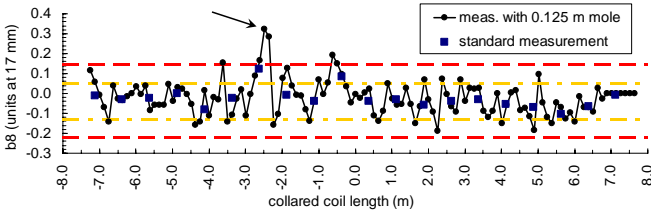
**Curing problems:** Fig. 11 shows magnetic measurements along the axis of  $b_8$  (bottom) in a collared coil. The field anomaly was compatible with a radial movement of block 6 of 0.4 mm. This case looked very similar to the curing problem described in the previous section. However, after de-collaring, a movement of block 6 of only 0.15 mm could be observed.

Fig. 11. Measurement of multipole  $b_8$  along the magnet axis with alarm limits for a collared coil with an expected block 6 movement.

The most probable explanation for these cases is that block 6 was misplaced during the collaring but correctly glued, and that after de-collaring it sprung back to the original position.

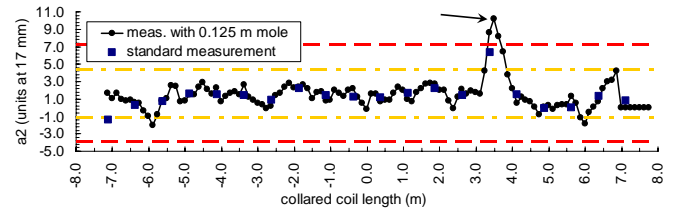
In a second case, from the measurement of multipole  $a_6$  shown in Fig. 12 (see arrow), a conductor movement of block 6 radially inwards of about 0.3 mm was predicted from inverse calculation and a curing problem was also suspected. After de-collaring, we observed that the curing was fully intact. However, block 6 was ill-positioned, *i.e.*, it was glued to the adjacent copper wedge with a radial movement towards the center of the aperture of about 0.1 mm. The amplitude of the visible movement did not match the prediction. In a third similar case, no visible block 6 displacements were observed.

**Anomaly in  $a_2$ :** Fig. 12 shows the field anomaly that was measured for  $a_2$  in one collared coil. The absence of anomaly on the high orders suggested that the defect is located in the outer layer. Even though no solutions were found, the magnet has been de-collared since the anomaly was very strong (more than 11  $\sigma$ ). The de-collaring has shown no visible defect. This case is hard to judge since no solution was available, and therefore no estimate of the coil movement was possible.

Fig. 12. Measurement of multipole  $a_2$  along the magnet axis with alarm limits (dashed lines) for a collared coil with an expected pole shim problem.
